# An Analytically Validated Highly Damped Repair for Acoustically - Induced Cracking on the F/A-18 Nacelle Skin

S.C Galea and R.J.Callinan

DSTO-TR-1162

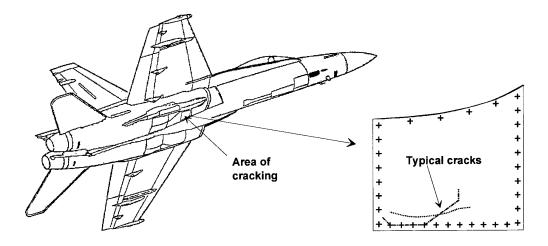
Figure 1 - Location of the cracking in the lower nacelle inlet.

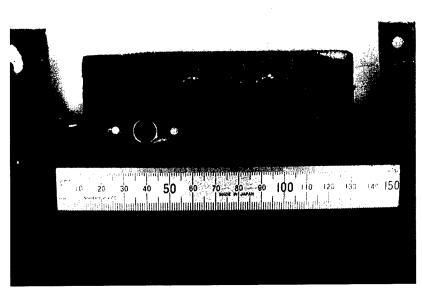
Figure 2. The panel from which the small piece was removed [8].

Both the length of the crack tip after the repair and flight hours are known for the right hand crack tip shown in Fig. 2, and is 2 mm/flight hour. While the crack growth rate before the repair is unknown it is thought to be considerably less than that after the repair. There is a possibility that before the repair, the rubbing of the crack faces provided some friction damping to the panel, this in turn led to a lower crack growth rate.

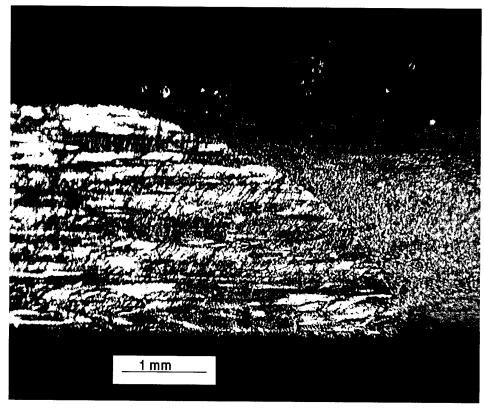
Figure 4. View of the tip of the crack in the thick end of the panel. The fatigue crack surface is the bright faceted region to the left and the deliberately broken surface is the mottled grey area to the right. Note the shape of the crack, much longer along the inside surface of the panel, indicating that a degree of bending was involved in the development of the crack. Also note that the fatigue crack surface is bright and highly detailed, and does not appear to have been rubbing [8].
